## October 2009 Electrical Safety Occurrences

There were 13 electrical safety occurrences for October 2009:

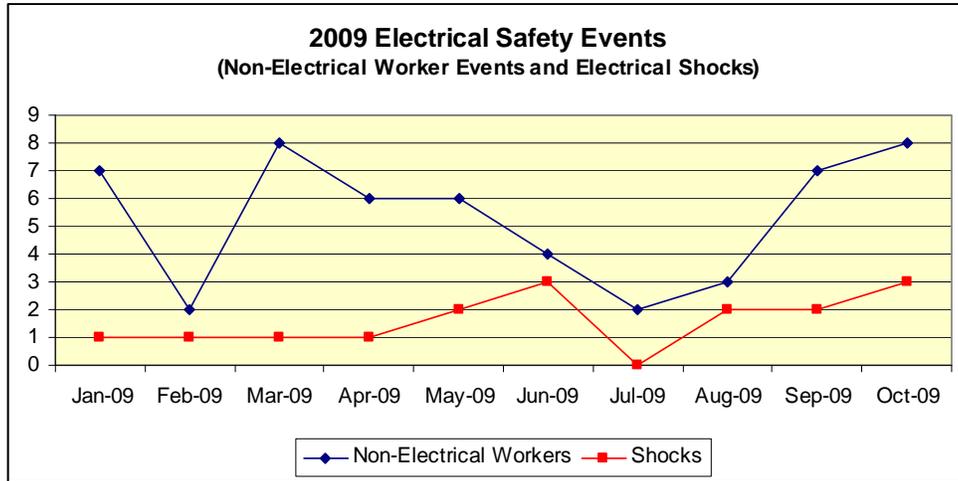
Since July 2009, there has been a steady increase in electrical safety events involving non-electrical workers. The main concern is the number of events in which non-electrical workers came in contact with electrical energy. So far this year there have been 20 electrical shocks, of which 16 involved non-electrical workers. In the first five months of 2009, non-electrical workers were involved in 29 electrical events with 6 resulting in an electrical shock. In the second five month period, non-electrical workers were involved in 24 events with 10 resulting in an electrical shock.

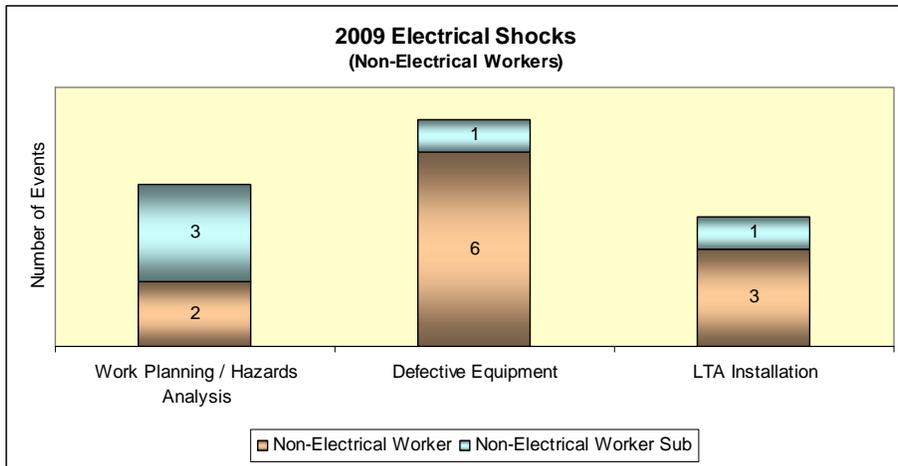
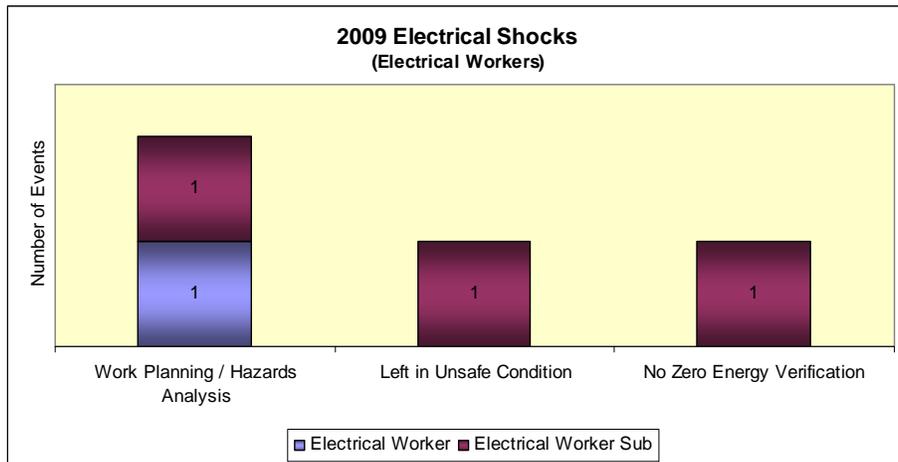
When we look at the causes for non-electrical worker shocks we see that 69 percent resulted from contact with defective equipment or less than adequate installations that provided an exposed hazard to the worker. The other 31 percent involved deficiencies in work planning/hazards analysis. If we look at the causes for electrical worker shocks we see that they are evenly divided between unsafe work practices and work planning/hazards analysis deficiencies. Subcontractors were involved in 31 percent of non-electrical worker events and 75 percent of electrical worker events.

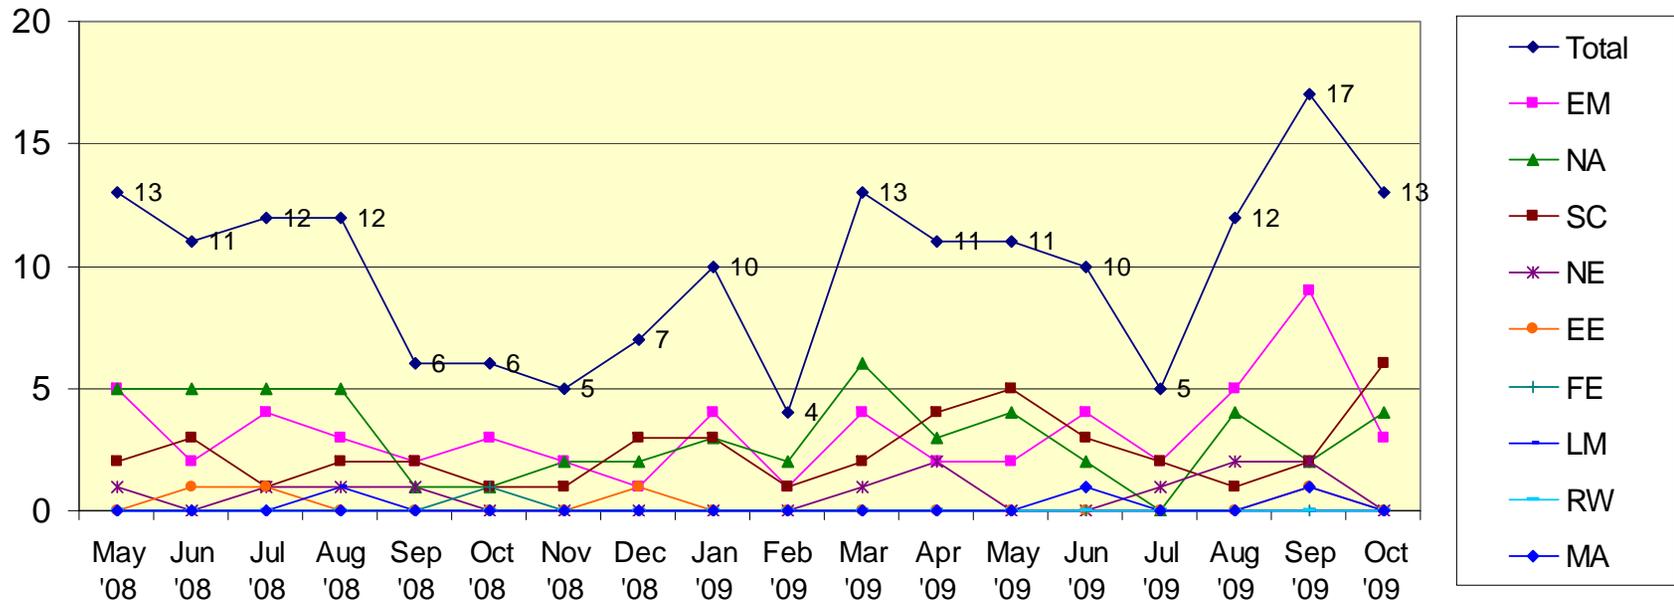
## Electrical Occurrences by Month & Secretarial Office

(Rolling 18-Month Chart)

EE - Energy Efficiency and Renewable Energy, EM - Environmental Management, FE - Fossil Energy, LM - Legacy Management, MA - Management, NA - National Nuclear Security Administration, NE - Nuclear Energy, RW - Civilian Radioactive Waste Management, SC - Science
